Shock Absorber Inspection: Misting versus Leaking

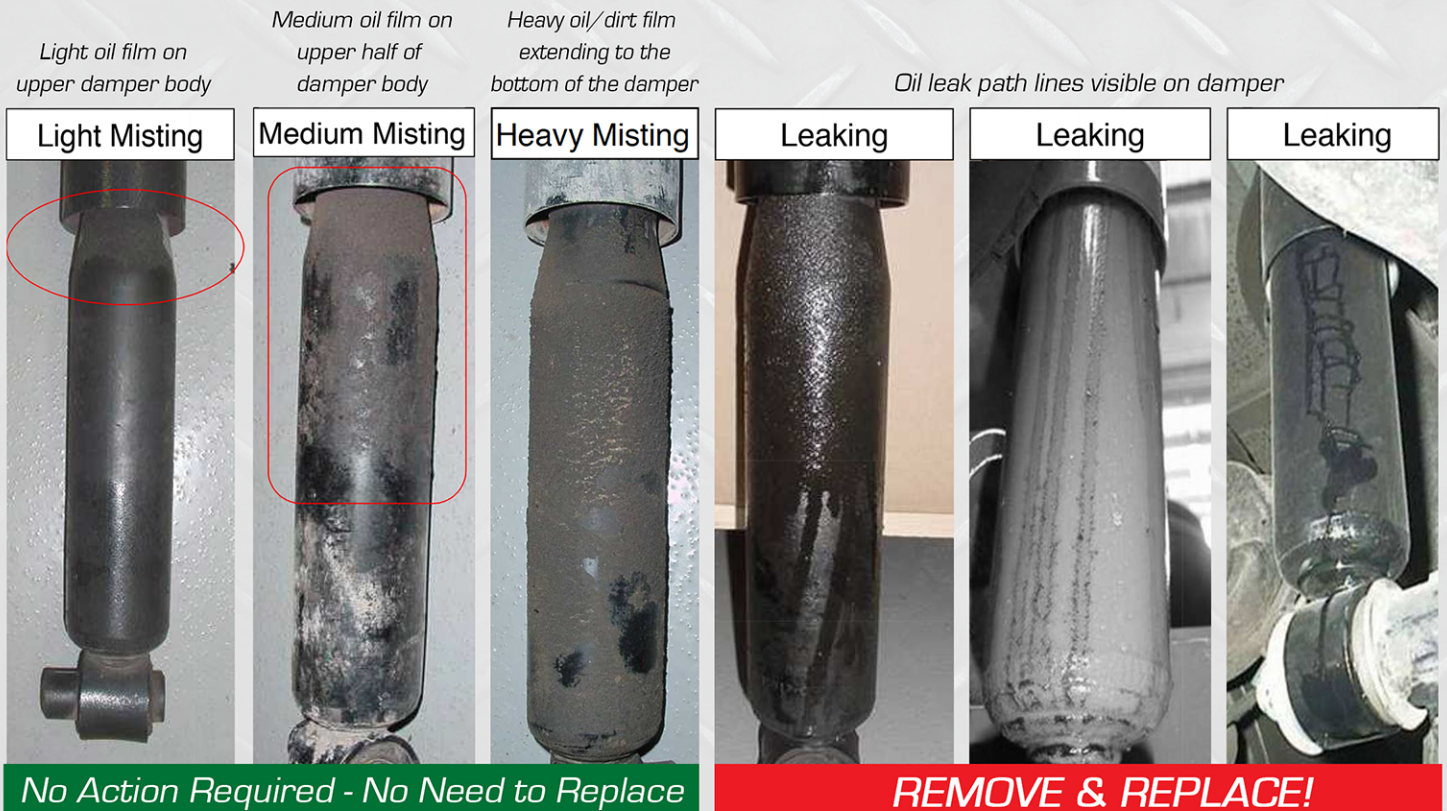
Misting is a perfectly normal and necessary function of a shock absorber. By design, the piston rod carries a film of oil through the rod seal to lubricate the seal lips, thereby reducing friction and wear at the seal contact area, and prolonging seal life. Misting occurs when the hot piston rod is drawn out of the shock body and some of the microscopic film of hot oil on the rod turns to vapor. This vapor, or mist, condenses when it reaches the cooler outside air, and forms a film on the outside of the shock body. The film will attract road dust and debris, and will sometimes coat the entire body of the shock.

Rod seals may leak as a result of extreme wear, contamination, or defect. A **leaking** shock will show clear signs of oil leaking in **streams** from the upper seal down the shock body and may drip from the shock.

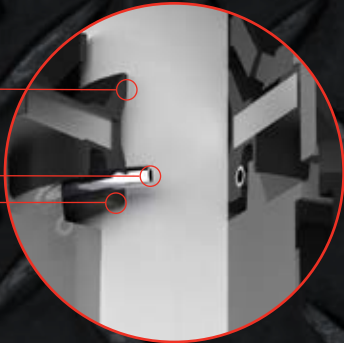
NEW Mist Reducing Rod Seal* provides LONGER LIFE

- Gas check lip keeps shock primed, even while parked
- Garter spring provides optimum rod sealing and seal life
 - ✓ *Reduces misting, extending the life of the shock*
- Dirt wiper reduces contamination entering the shock
 - ✓ *Extends the life of the shock*
