BULLETIN CATEGORY: Technical

SUBJECT: Gabriel® Product Benchmark – Chrome Plating

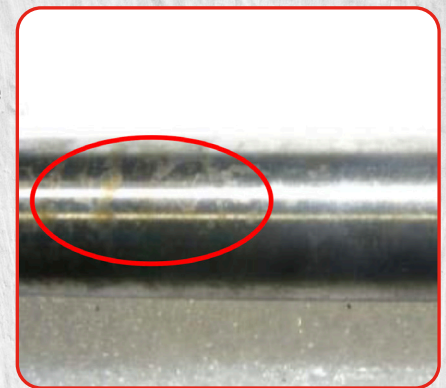
FIGURE 1

Chrome plated rods increase product shelf life. Moisture in most storage environments will cause unprotected steel surfaces to corrode over time. Figure 1 shows a competitive shock rod that oxidized in the box on a retailer's shelf.

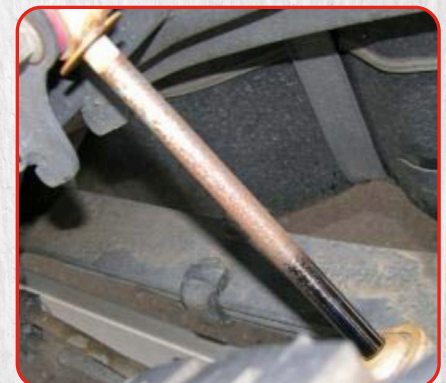
FIGURE 2

Chrome plated rods prevent "Lot Rot" which results when a vehicle is parked for an extended period of time. The damper must be cycled if

the piston rod is to remain lubricated thereby preventing corrosion. Premature seal failure will result causing the damper to leak (see Figure 2).

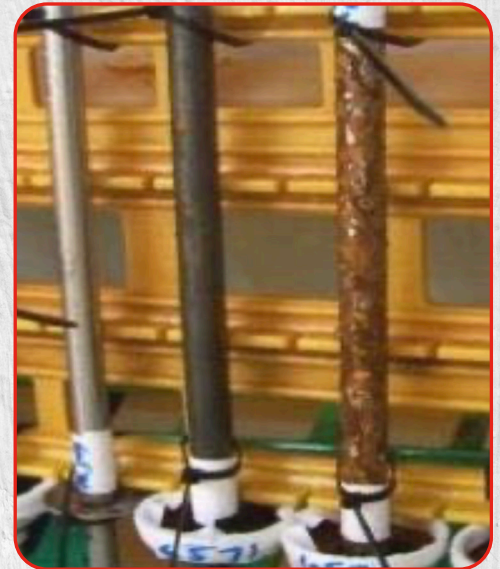
FIGURE 3

The Gabriel engineering team in Farmington Hills, MI subjected parts to the salt spray for 96 hours as defined by ASTM B117 which is the industry standard when developing shocks for new vehicles. After only 25 hours of testing the competitor's raw steel rod was completely oxidized (Figure 3, right). The nitrocarburized piston rod (Figure 3, middle) was already beginning to oxidize. The Gabriel chrome plated rod (Figure 3, left) exhibited no signs of rust on the rod surface.

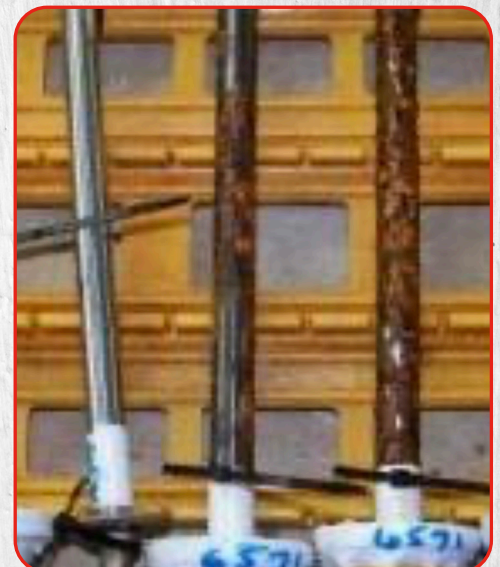
FIGURE 4

After 96 hours of oxidation the Gabriel chrome plated rod (Figure 4, left) retained its smooth chrome finish guaranteeing a long service life. The nitrocarburized piston rod (Figure 4, middle) is oxidized and would no longer function.
