# TECHNICAL BULLETIN

#### # 0514024

## SUBJECT: Shouldered Stud Installation PART/VEHICLE: G63929 (92-07 Ford E-Series)

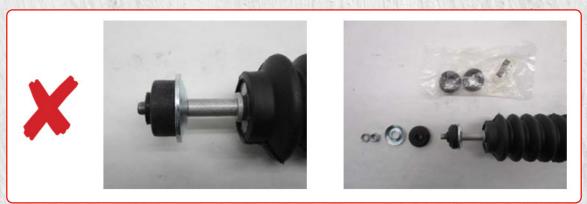
Installer unable to install the upper hardware on stud ended shocks designed with a "shoulder". A shouldered stud is defined as a stud that has a non threaded zone that is larger in diameter than the threaded zone.

Installing the retainer with the small hole first does not allow enough room to install the upper cushion, retainer and nut.
