# 04122019

**BULLETIN CATEGORY:** Technical

**SUBJECT:** ReadyMount® Complete Strut Assemblies Installation Tips

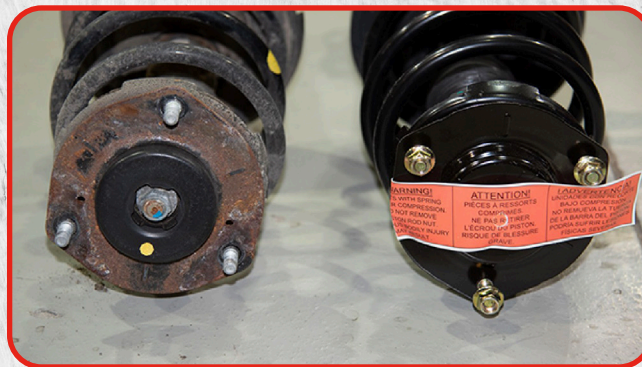
**PROBLEM DESCRIPTION:** For some ReadyMount Complete Strut Assemblies with bearings in the top mount, out of the box, the studs in the upper mount may not line up with the mounting holes on the vehicle.

On some vehicle applications, the upper mount can be rotated freely. In this case, insert the studs at the top of the strut assembly in the car's mounting holes before installing/tightening any mounting hardware at the bottom of the strut.

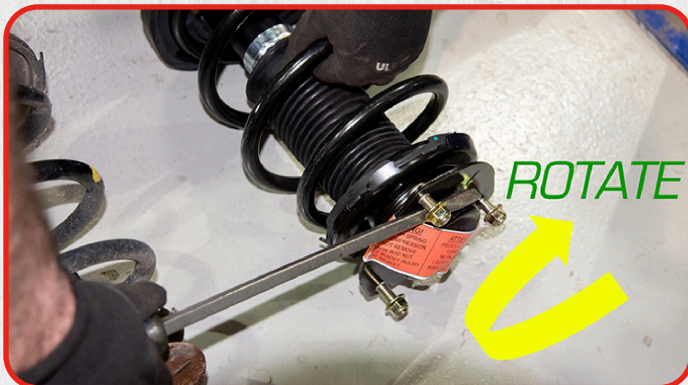
**FIGURE A**

On other vehicle applications, the upper mount cannot be easily rotated. In this case, the upper mount can usually be turned slightly by prying with a screwdriver between two of the upper mounting studs. *See Figure A.*

**NOTE:** Prying between the mounting studs without nuts attached can cause thread damage.
