SUBJECT: Shouldered Stud Installation

PART/VEHICLE: G63929 (92- 07 Ford E-Series)

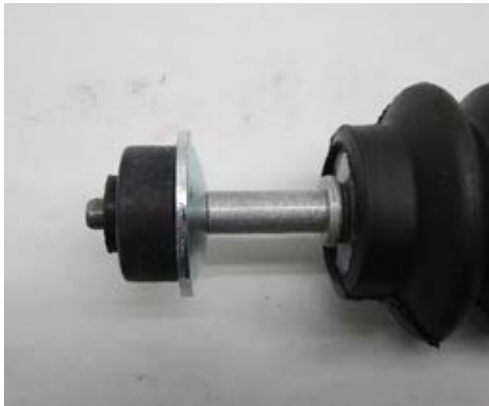
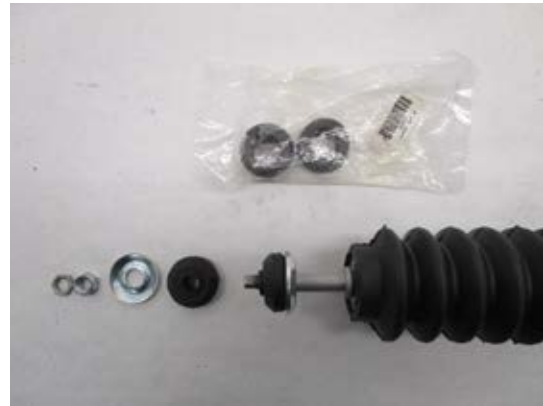
Installer unable to install the upper hardware on stud ended shocks designed with a “shoulder”. A shouldered stud is defined as a stud that has a non threaded zone that is larger in diameter than the threaded zone.

NOTE: The mounting kit includes two retainers with different size holes

Installing the retainer with the small hole first does not allow enough room to install the upper cushion, retainer and nut.

Installing the retainer with the large center hole first allows plenty of threaded area to install the shock.
