INTRODUCING FleetLine[®] 85200

FLEETLINE[®]

Heavy Duty Commercial Vehicle Shock Absorbers

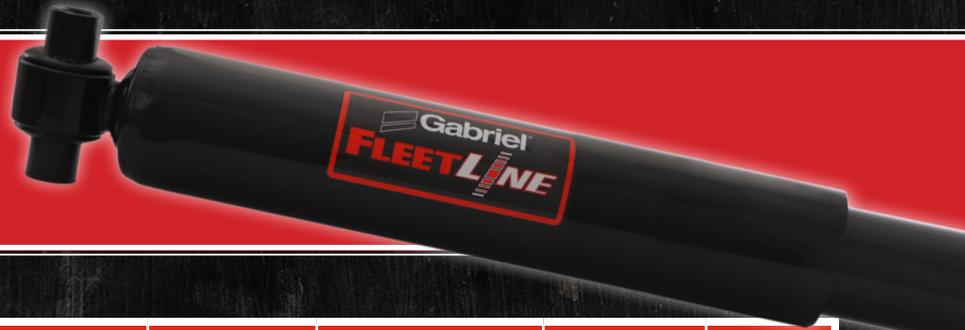
Make	Series	Model Description	Year	OEM Number	FleetLine [®] Number	Position
Freightliner	Cascadia	Models with Hendrickson Airtex NXT Front	2018 - 2024	58913015	85200	Front
				58913-015		
				58913-015L		
				HDR 58913 015		
Western Star	57X	Models with Hendrickson Airtex NXT Front	2023 - 2024	58913015	85200	Front
				58913-015		
				HDR 58913 015		
				58913-015L
